## ***Quaker Meeting House, Wellington***

*High Street, Wellington, Somerset, TA21 8RA*

### ***Statement of Significance***

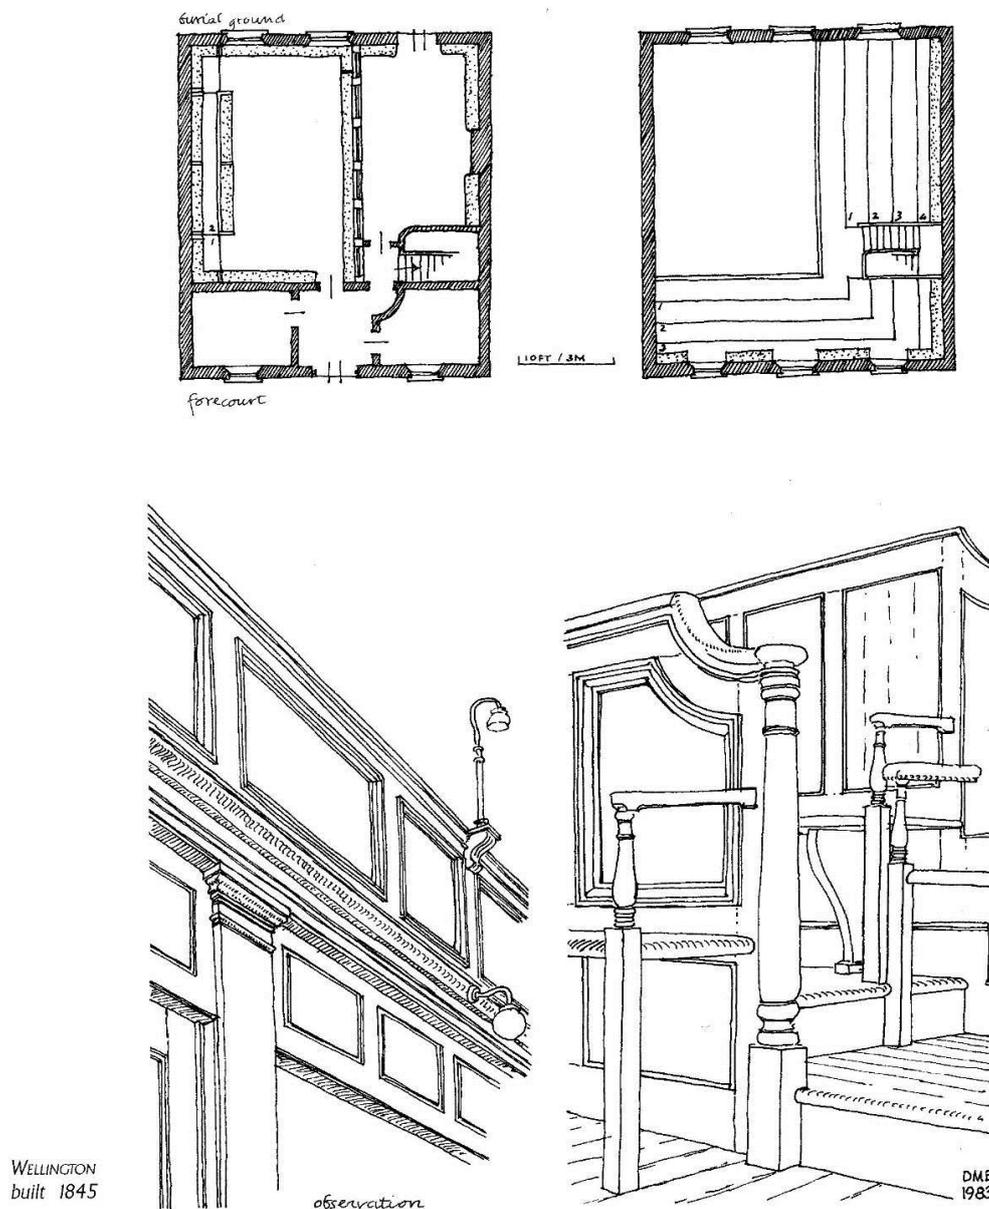
Figure 1: ground and first floor plans and details from the main meeting room. North is to the bottom of the plan. (Butler, vol. 2, p. 550)

The internal arrangement is ingenious (see figure 1) with large and small meeting rooms placed side by side and with an L-shaped gallery over the small meeting room and entrance lobby. The large meeting room has a boarded floor, a tall panelled timber dado, plain plastered walls above the dado, a simple moulded plaster cornice and a flat ceiling with a central ventilator roundel with acanthus ornament. On the long east side is a ministers' stand with a panelled front and all the other walls have perimeter benches. On the west side is a panelled screen with pilasters and central shutters to the small meeting room (still in working order). Above the screen and continuing on the north side is a gallery with a panelled front. The gallery retains its original benches and gas-light fittings. The small meeting room has a chimney breast on the west wall and was apparently unlighted before the insertion of the door in the south end wall. The stair in the lobby leading to the gallery has a shaped curving handrail and stick balusters. The joinery throughout is of high quality.
